**DRAFT Fishery and Water Quality Monitoring of Pajaro River Lagoon/Estuary,
2020**

(Sampling for Tidewater Goby under USFWS Endangered Species Recovery Permit TE-793645-4)

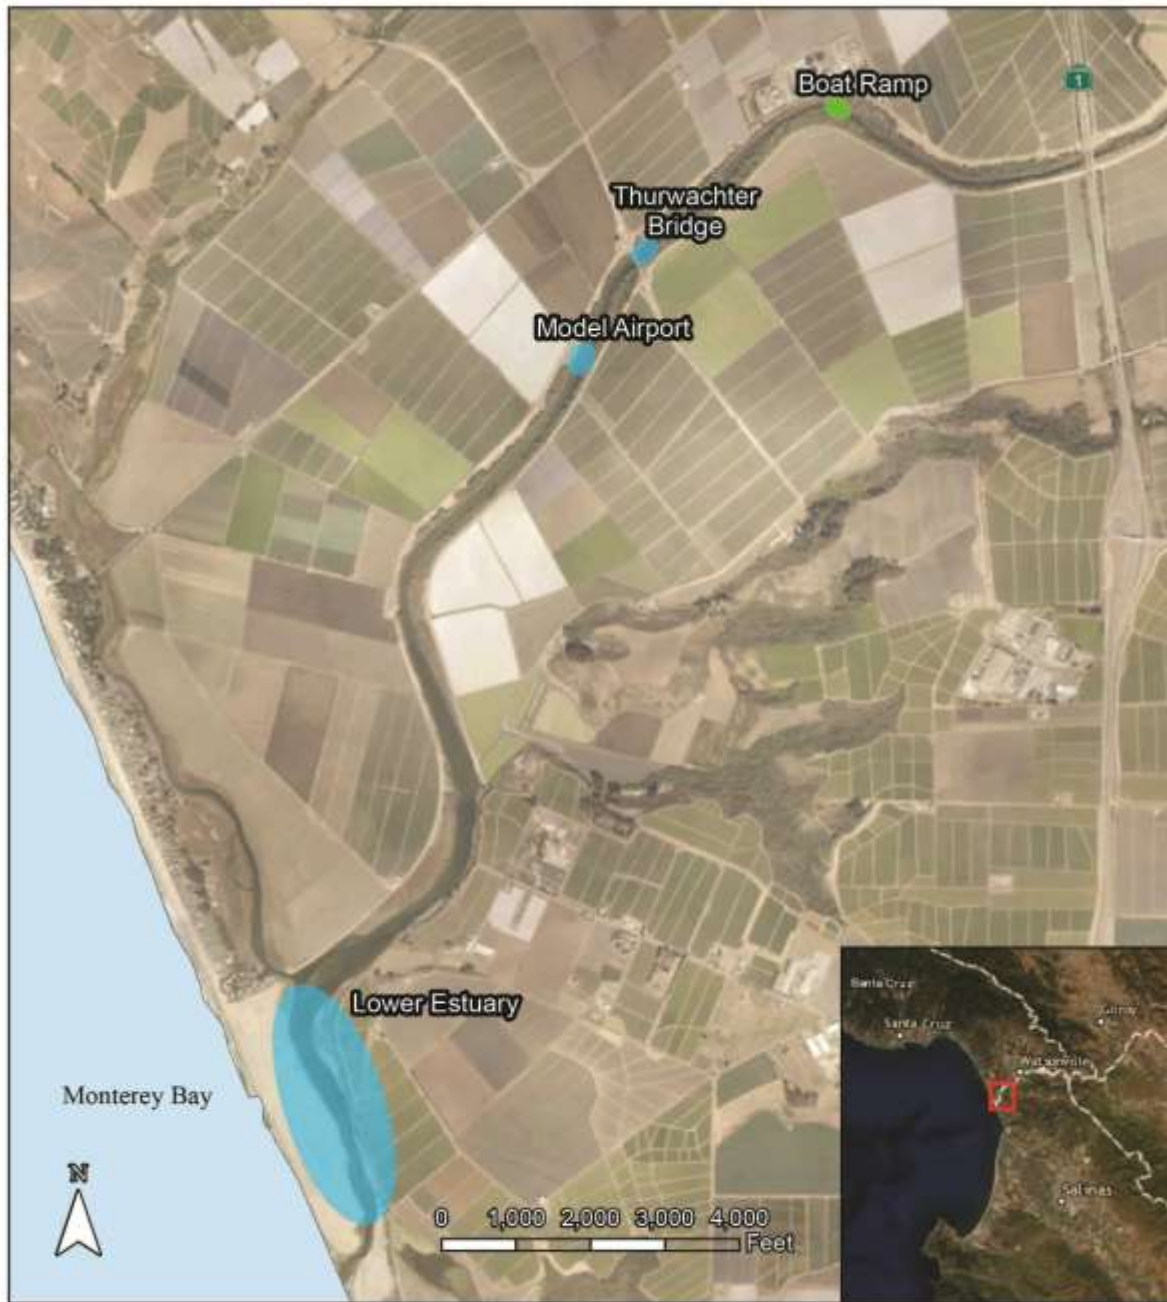
Figure 1. Pajaro Lagoon Fish and Water Quality Sampling Sites

Pajaro Estuary (open sandbar) was sampled on September 28–30, 2020. Sampling locations included the beach area, Watsonville Slough approximately 100 m from its mouth and sites adjacent to the model airport (1.8 miles upstream of Watsonville Slough), at Thurwachter Bridge (2.1 miles upstream of Watsonville Slough) and behind the City of Watsonville wastewater treatment plant at the boat ramp (2.9 miles upstream of Watsonville Slough) (**Figure 1**).

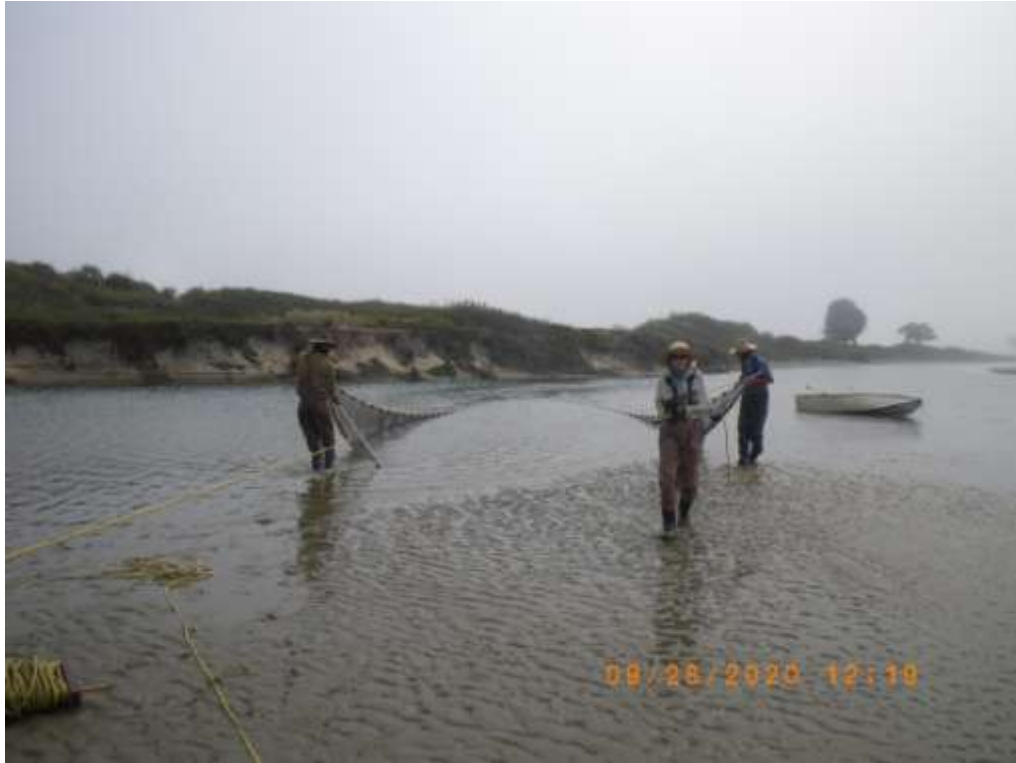
Lower Pajaro Estuary looking northeast, sampling the thalweg (deepest portion of the channel) with seine haul #7. (D. Alley) 28 September 2020
