2021 Juvenile Steelhead Densities in the Corralitos Creek and Casserly Creek Watersheds

Prepared for:

City of Watsonville,
275 Main Street, Suite 400
Watsonville, CA 95076

Mike Podlech, Aquatic Ecologist

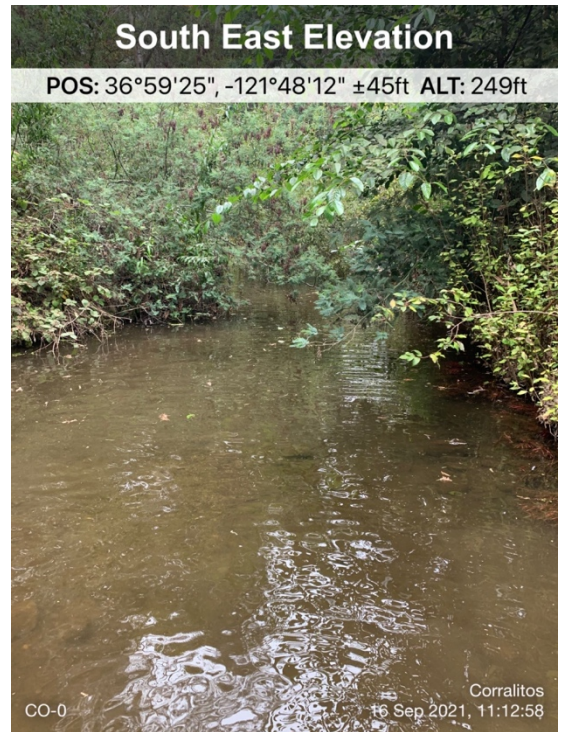
Photo 2. CO-0 pool, Sep. 16, 2021

hydraulic control for this pool. In 2021, the concrete slabs remained, but most of the channel width now consists of a cobble tail-out with an embeddedness rating of 0-25%. The mean pool shelter rating was 40, representative of low shelter abundance, and consisted of bedrock ledge, some root mass, and terrestrial vegetation overhang. Sand was the dominant substrate type in the pool, and large cobbles were the dominant substrate in the flatwater step-run. Canopy cover was estimated at 40% and composed almost entirely (95%) of hardwood species.

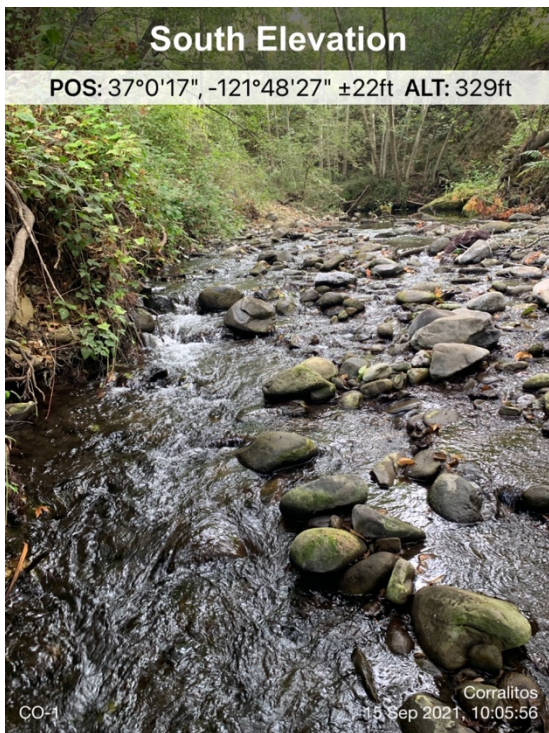
Photo 3. CO-1 riffle, Sep. 15, 2021

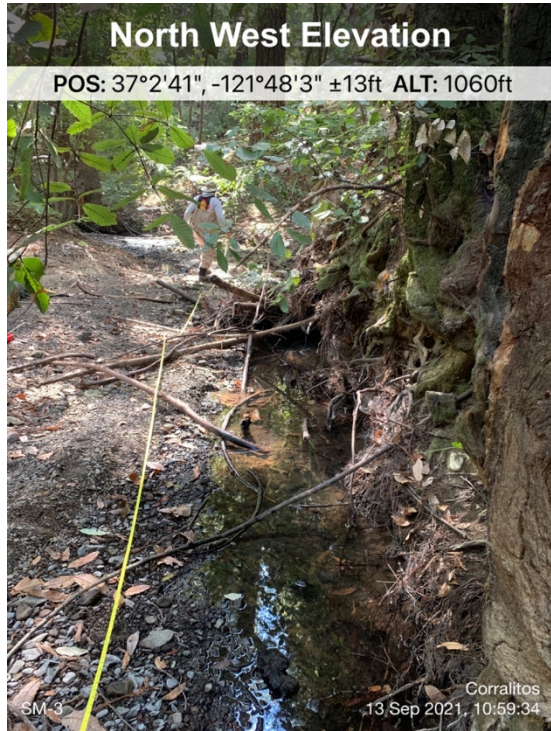
Photo 9. SM-3 pool, Sep. 13, 2021

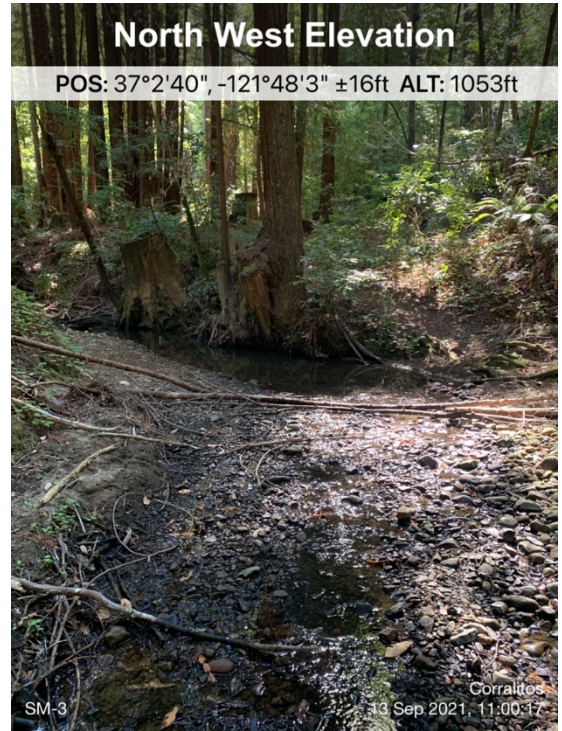
Photo 10. SM-3 riffle-pool transition, Sep. 13, 2021

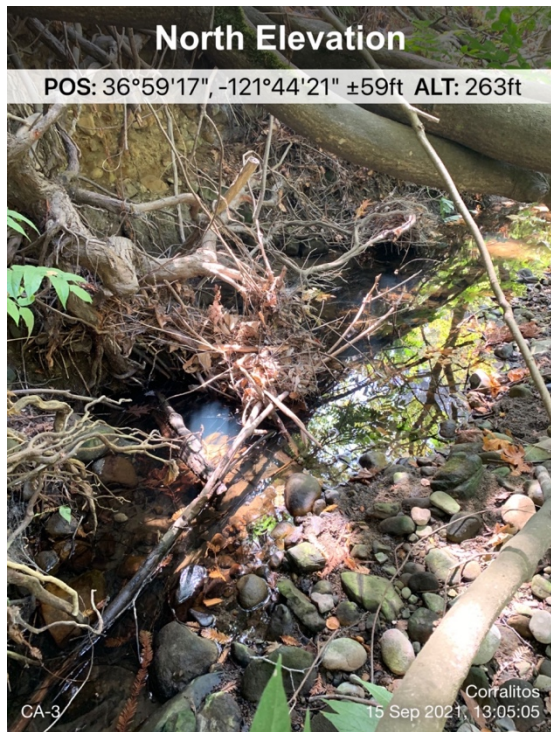
Photo 15. CA-3 pool, Sep. 15, 2021
